ARL-STRUC-TM-503

Aircraft Structures Technical Memorandum 503

EVALUATION OF A DAMAGED F/A-18
HORIZONTAL STABILATOR (U)

J. PAUL

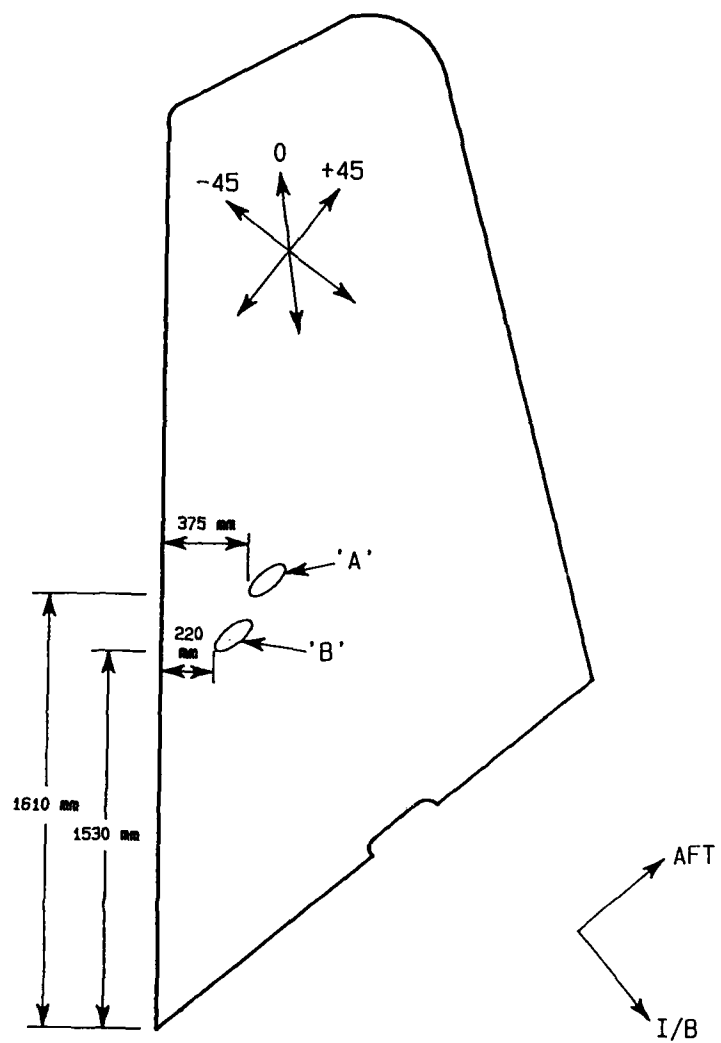
FIGURE 1 F/A-18 HORIZONTAL STABILATOR WITH DAMAGE LOCATION

The horizontal stabilator had incurred two strikes by fragments, approaching from the rear, near the leading edge, see Figure 1. Both fragments caused extensive local damage to the composite skin and underlying honeycomb, but neither fragment penetrated to the other side of the stabilator. As seen in Figure 1, the two damaged areas are roughly the same size and both strikes have caused additional delamination in the skin, see Figures 2 and 3. The damage zone was C-scanned to determine the amount of additional delamination. However, interpretation of the C-scan results was made

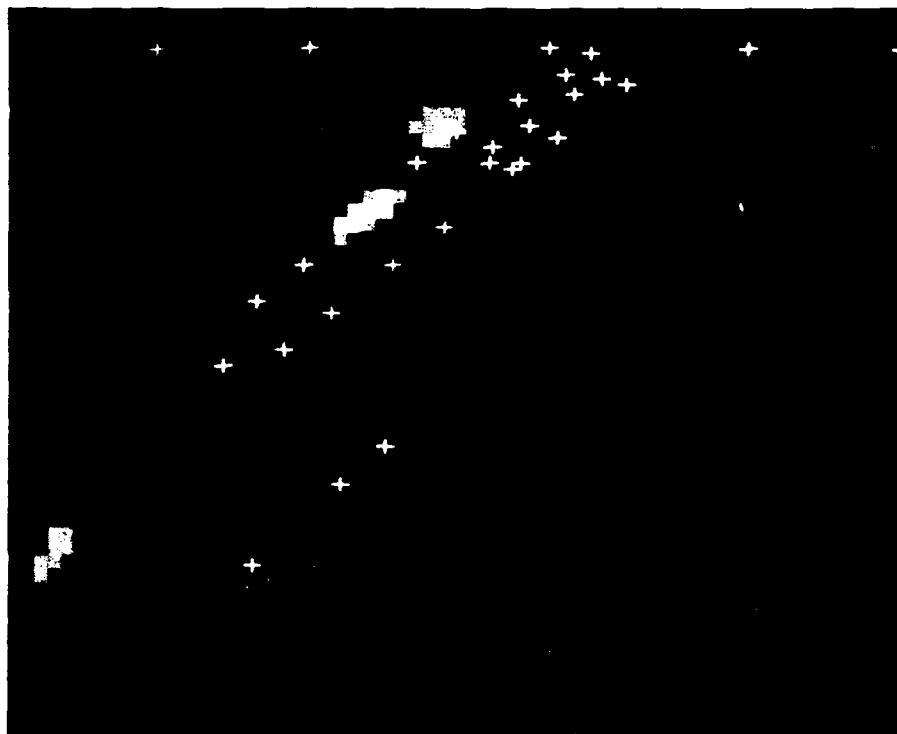
FIGURE 11 SPATE PICTURE OF DAMAGE ZONE

To investigate the stress concentration around the damage further, a number of detailed thermal emission scans were taken. The SPATE photo is orientated as a mirror image of Figure 8. The results of one of these scans is shown in Figures 11, and to assist the reader in interpreting the picture, an overlay is provided Figure 10. Examination of this figure reveals that, as indicated by the strain gauge and compliance measurements, there was no 'classical' stress concentration affect around the damage. There is also a region, in the vicinity of gauge U2, which gave a spurious thermal emission reading. This spurious reading vanished when the structure was excited at 12 Hz.

The strain survey conducted indicates that there is minimal structural degradation resulting from the fragment strikes. The results also show that the damage produces no measurable change in local compliance. The thermal emission results confirm these measurements and do not show the classical stress concentration around the fragment holes. Since the damage does not appear to compromise the compliance of the structure a simple externally bonded repair should suffice. This investigation has revealed that such a repair will not result in a significant change in the local neutral axis or an associated increase in secondary bending.
